Burford's Shopfronts

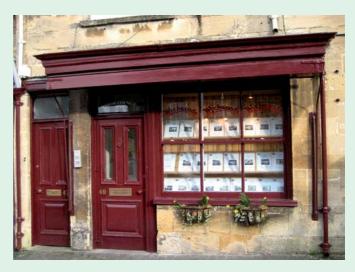
Figure A The 18th-century apothecary's shopfront at 124 High Street, still a chemist's shop. The large sash windows are typical of the period.

Shopfronts have always been one of the most frequently replaced parts of town buildings, as on any modern High Street. Like many towns, therefore, Burford has few early examples despite its rich variety of domestic fronts. The earliest to survive, other than the fragments of a medieval shopfront inside III High Street (Panel 3), is the important 18th-century front at 124 High Street, converted from an inn to an apothecary's shop c.1734. Inside are drawers and fitments of the period.
